**Institute of Transportation,  
Ministry of Transportation  
and Communications,  
R.O.C.**

PRESS RELEASE on Mar 3, 2020

## **The Creation and Application of the Track Fastener Defect Identification System**

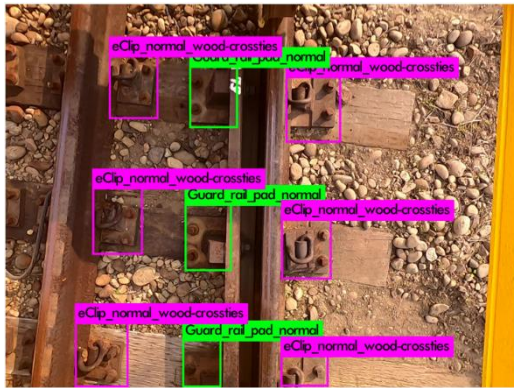
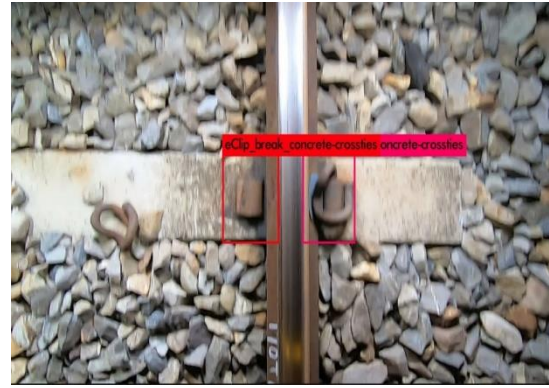
(a) Track fastener image automatic identification (b) Left: a defective fastener Right: a normal fastener  
Figure 1 Track fastener defect automatic identification

The track fastener image extraction equipment constructed by the IOT includes cameras and lighting devices. Within the jurisdiction of the TRA, one railway track section was selected to obtain clear images that AI can adequately identify. Through image tagging and the adoption of Yolo v3 AI identification software, deep learning model training was carried out to create the Fastener Image Inspection and Automatic Identification System, which can be used to detect railway track fasteners that have come off. For the image extraction part, sports-type cameras (GoPro) are adopted at

present for video recording. Night inspection vehicles at the speed of 30km have recorded images of track fasteners of railway which length is more than 70km, with a fastener image identification accuracy of 86.7%. In the future, further improvements will be made, hoping to ultimately achieve the purpose of replacing manual inspections with railway track fastener AI image identification.

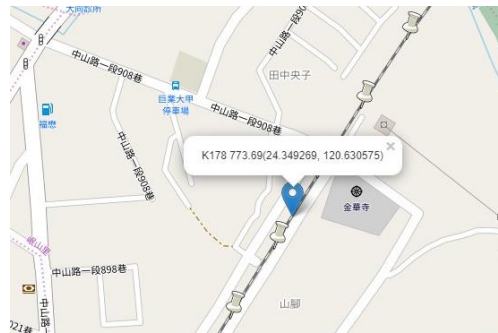
Figure 2 Track fastener defect positioning

In addition, in order to enable inspectors to conveniently detect defective fasteners for repair, a system including cloud storage, identification and search functions have been developed, allowing Google Map to display and position defective fasteners pending repair by TRA personnel. The system (equipment included) about NT\$1 million in cost can assist TRA track maintenance section personnel in inspecting track fasteners, determining defects and engaging in positioning and repair; it can also be provided for use by railway maintenance and inspection units to enhance track inspection efficiency, facilitate maintenance and repair, and improve the safety of tracks.
