Institute of Transportation,
Ministry of Transportation and
Communications, R.O.C

PRESS RELEASE on
Feb 10, 2023

Mechanical Arm to Facilitate Bridge Beam Bottom Detection: Improving the Quality of Bridge Inspections

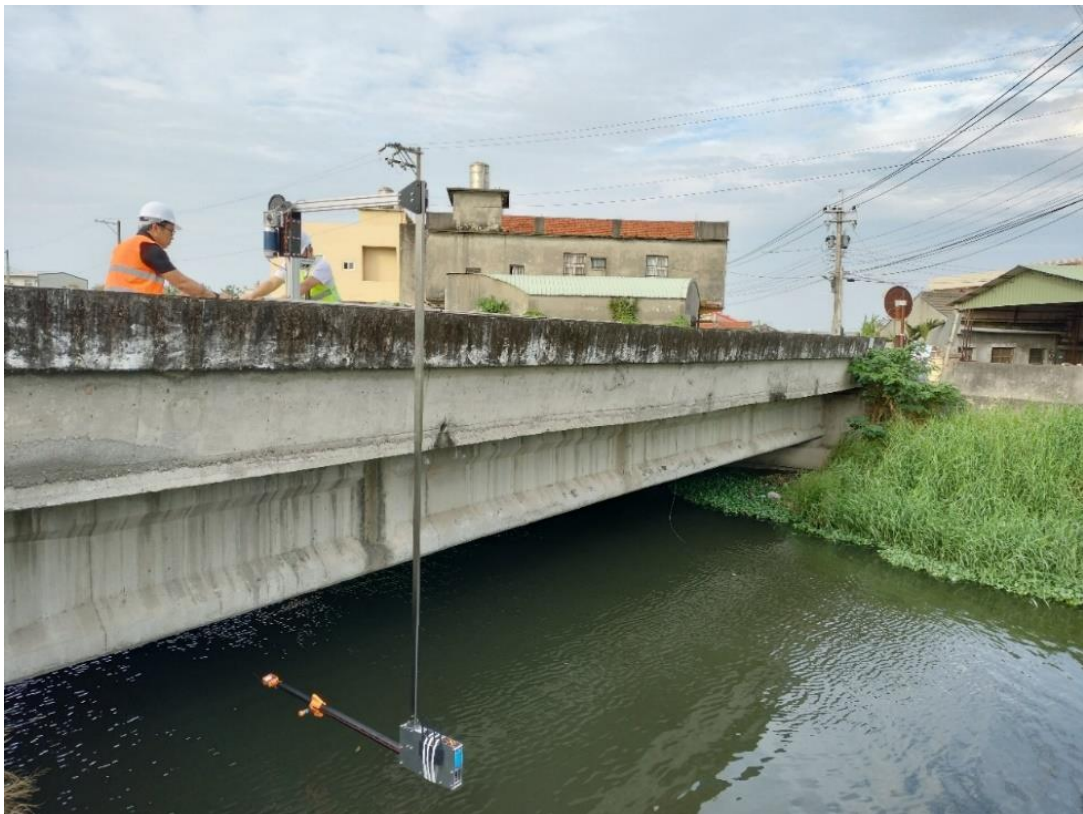
Figure 1 On-the-spot survey using the bridge inspection tool developed by IOT

This bridge inspection tool was used to inspect a 20-meter-long, 10-meter-wide bridge. It took approximately 90 minutes to capture an image of the bottom of the beam. Although it takes significantly longer than a manual visual inspection (about 40 minutes), this bridge inspection tool can record a complete image of the beam's bottom components, thereby reducing inspectors' risks during inspection work. The bridge inspection tool's conception is both technologically advanced and practically useful. It has obtained an invention patent (No. I741701) from the Intellectual Property Office of the Ministry of Economic Affairs.

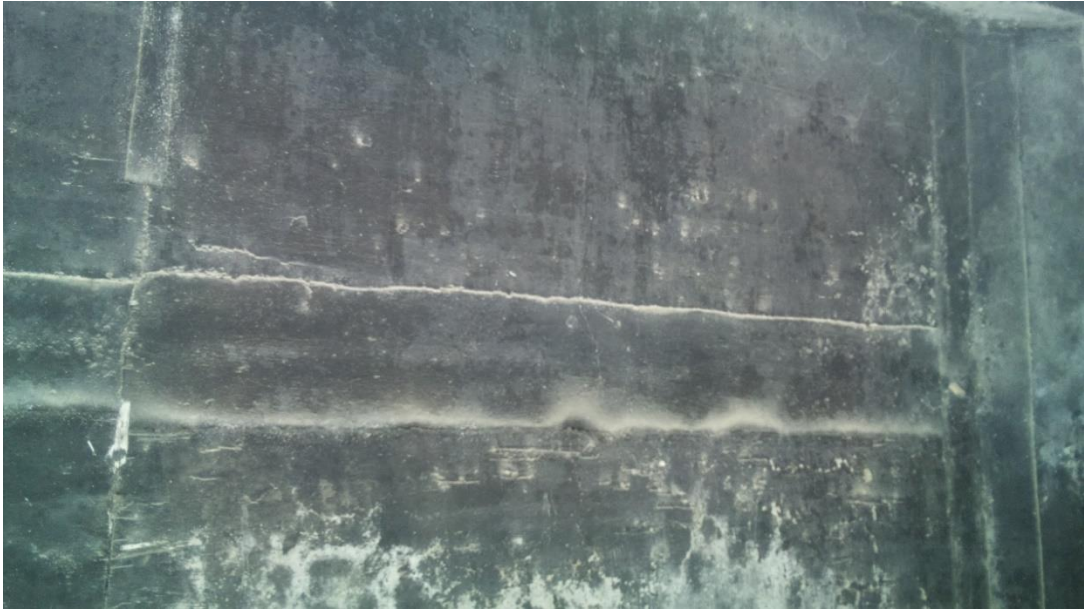
Figure 2 Image of the beam bottom captured by the detection tool

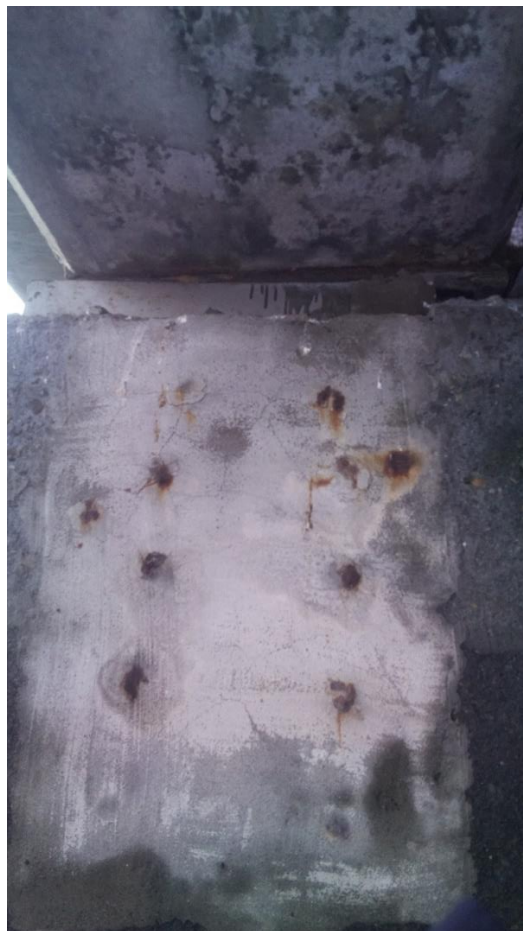
Figure 3 Lateral view of girders, bearings, and cap beams captured by the detection tool

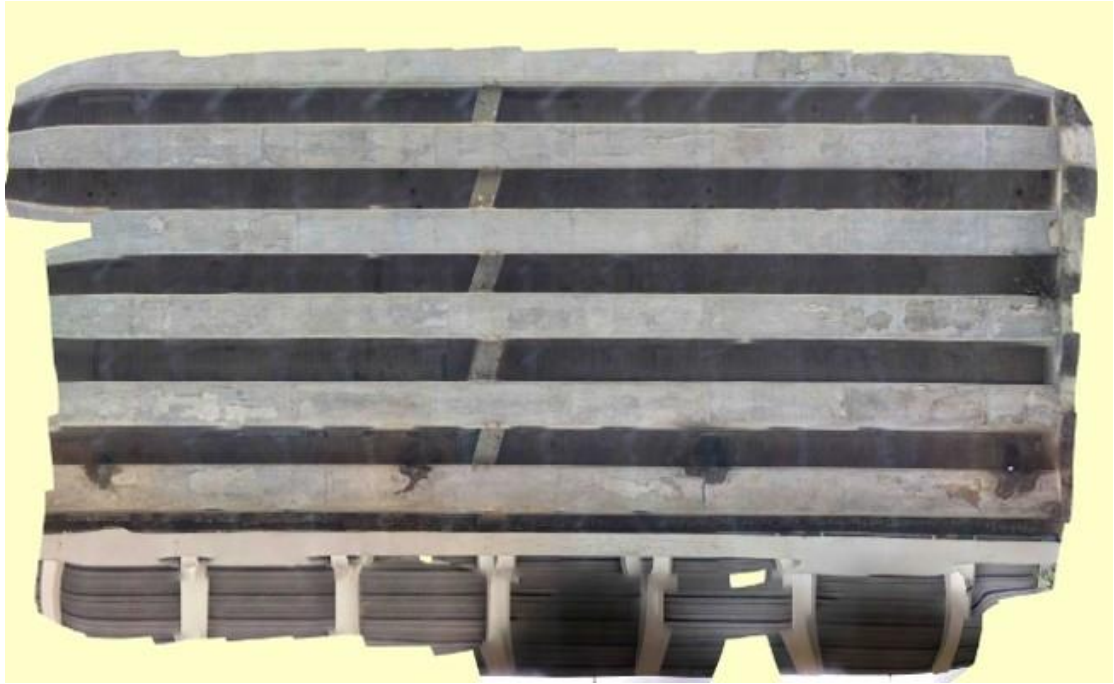
Figure 4 Image of baseboard stitching on the bridge
